Upper Saint Johns Lidar Project

Report Produced for U.S. Geological Survey

USGS Contract: G16PC00020

Report Date: 01/07/2019

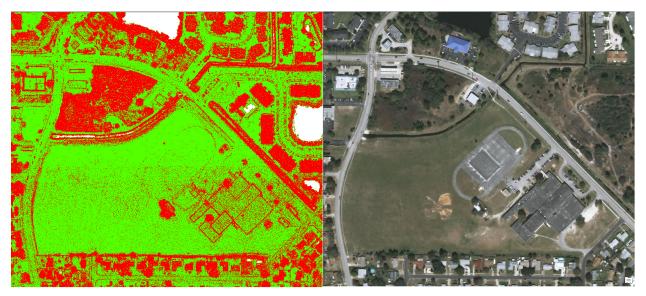
Figure 7 - Intra-swath relative accuracy. The left image is a close-up of a flat area. With the exception of trees and a few buildings (shown in red as the elevation/height difference in vegetated areas will exceed 6 cm) this open flat area is acceptable for repeatability testing. The right image shows aerial image of the same area. Intra-swath relative accuracy passes specifications.

Dewberry verifies the intra-swath or within swath relative accuracy by using Quick Terrain Modeler (QTM) scripting and visual reviews. QTM scripting is used to calculate the maximum difference of all points within each 1-meter pixel/cell size of each swath. Dewberry analysts then identify planar surfaces acceptable for repeatability testing and analysts review the QTM results in those areas. According to the SOW, USGS Lidar Base Specifications v1.2, and ASPRS Positional Accuracy Standards for Digital Geospatial Data, 10 cm Vertical Accuracy Class or QL1+ data must meet intra-swath relative accuracy of 6 cm maximum difference or less. The image below shows two examples of the intra-swath relative accuracy of Upper Saint Johns Lidar; this project meets intra-swath relative accuracy specifications.

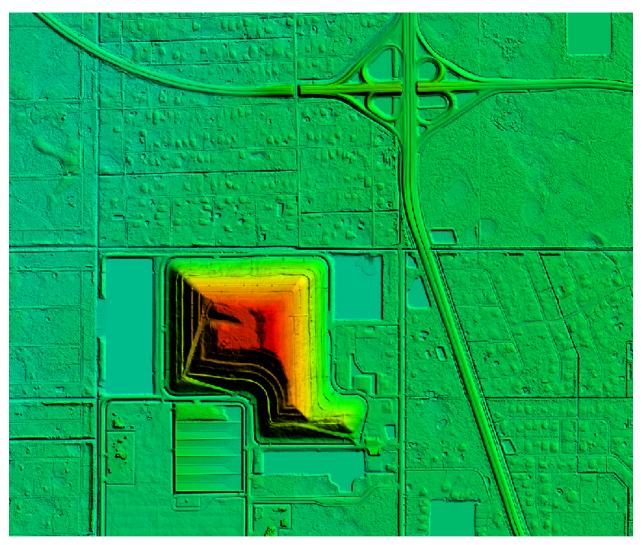
Figure 256-Tiles 261108, 261109, 261408 and 261409. The bare earth DEM is shown in the image above.

The images below show an example of a bare earth DEM.
